Technický bulletin

n. 2/08

Mercedes Sprinter 3.0 CDI Euro4 184HP mot. OM642 - A07MB119 - A07MB120

Renault - Opel - Nissan 2.5 Dci 120 Hp My 06 1RE20200E + A03130

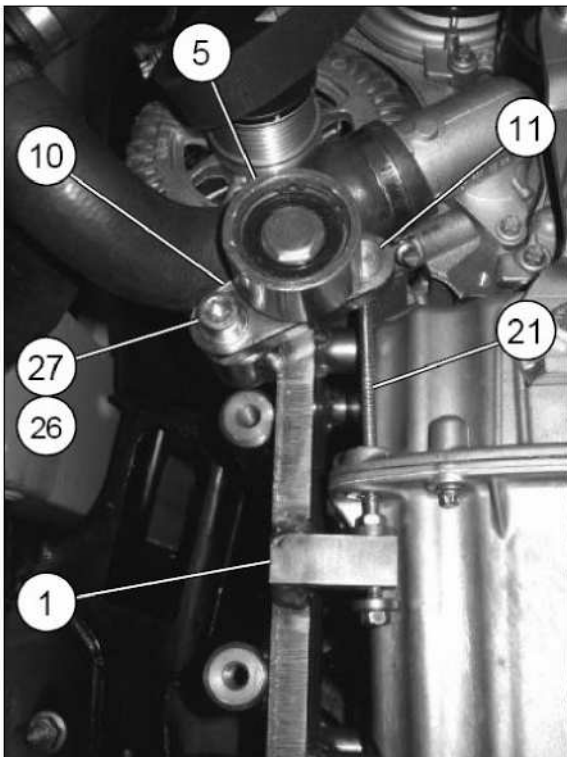
FOTO1

The kits A07MB119 (SP15) and A07MB 120 (SP21) can create some fitting problems with engine prepared as in the 3 attached picture, due to an interference between the idle pulley 5 and the water pipe or between screw 26 and the belt. To avoid these problems, tension properly the belt using screw 21. For further details please contact the Service Department.

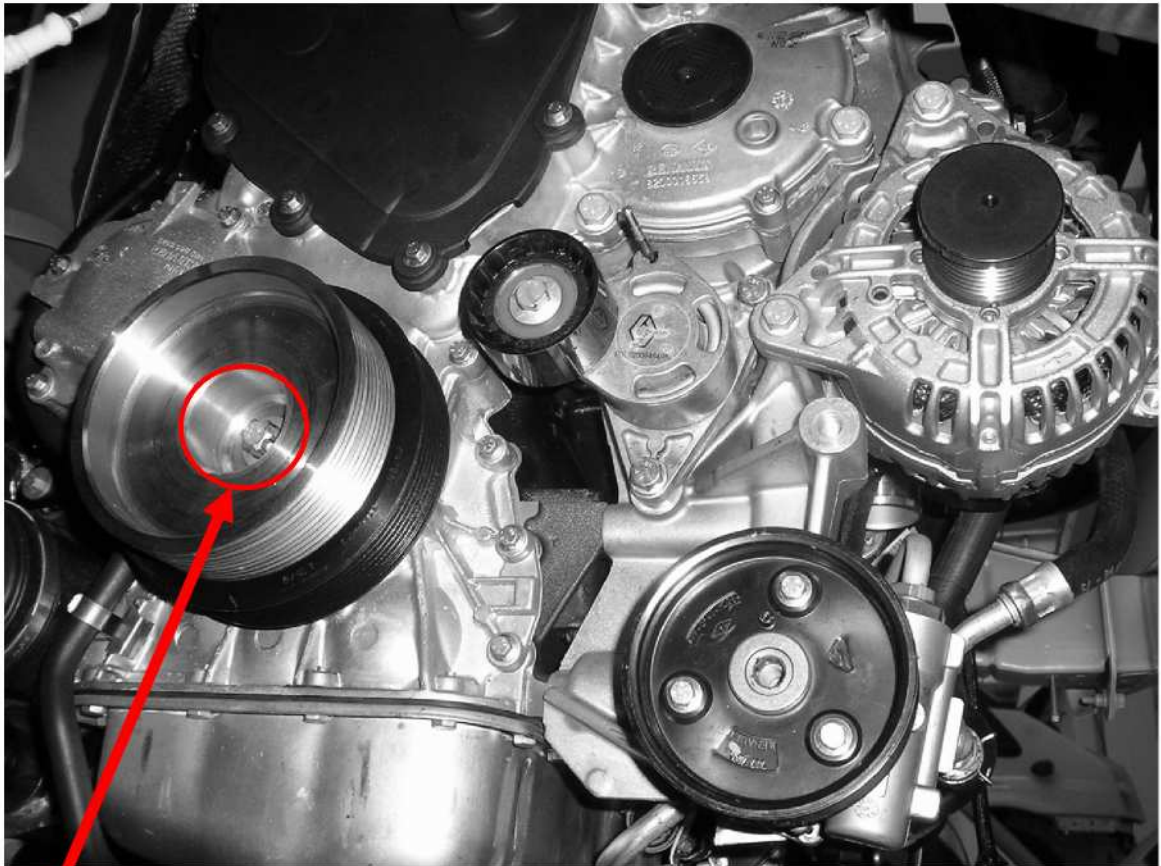
During the installation of our pulley 003772/0, REPLACE the original screw with a NEW one, as suggested in the official Renault/Opel/Nissan documentation and use a torque of $50\text{Nm} + 90^{\circ} \pm 6^{\circ}$.
For further details please contact the Service Department.

Slovensky: Nahrad'te originálnu skrutku novou skrutkou.
ENGLISH: Replace the original screw with a new one
